## 2011 ACTIVITY REPORT OF THE HCP\_AF GROUP

### 1. Aim of the experiment

### 3. Brazed section internal inspection

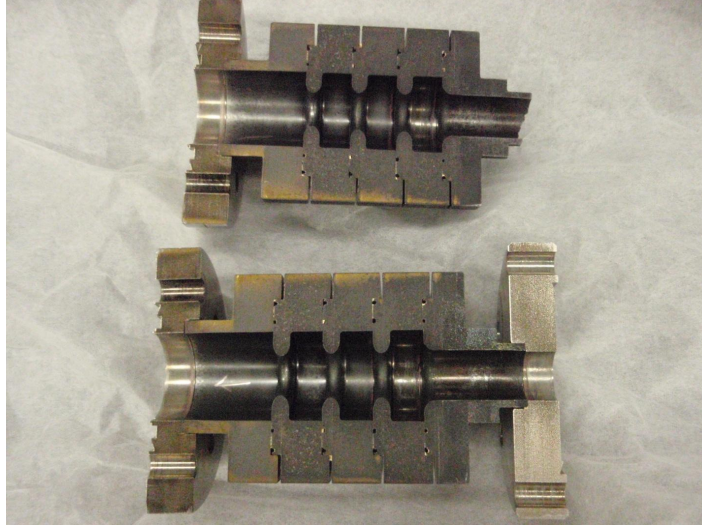
After being removed from high gradient test area, the structure was sectioned along the axis at SLAC klystron lab to allow for internal inspection [9]. The structure was first split into 2 pieces using EDM (Electrical Discharge Machining). One of the half pieces was split again. On the initial sectioning, one of the molybdenum “extension tubes” failed adjacent to the SST flange braze, as shown in figure 1. Note that the arrow shown in the image was observed by the machinist, not added during the cutting.

Fig 1 Moly structure was split up into 2 pieces using EDM

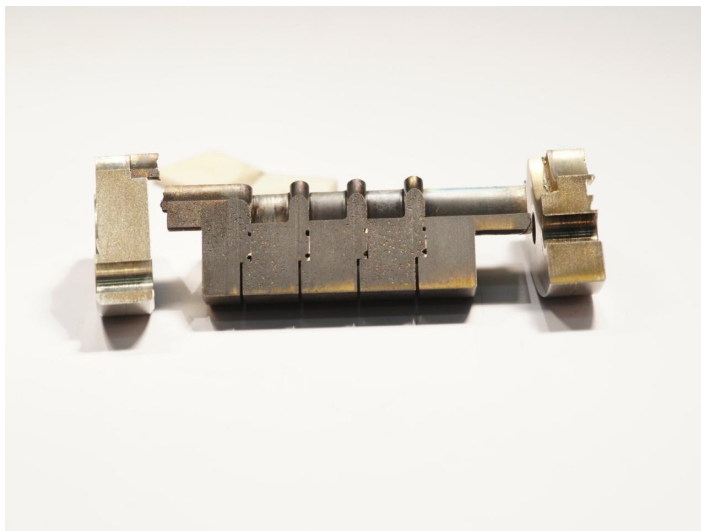
When one of the sections was cut again [also by EDM both flanges on one of the pieces (a 1/4 section of the whole) detached as shown in figure 2. It appears that in the case where the joint failed in the braze area (see figure 3), the molybdenum cylinder wall was thick enough to withstand the differential expansion forces but that the braze joint was not. In the case of the other end, the thinner molybdenum wall was insufficient to withstand the forces applied (see figure 4). On closer inspection we found that the joint was not completely filled with alloy which would result in uneven loading and increased/concentrated stress. We think that this increased stress between SST and molybdenum may have contributed to both failures. We speculate that during braze cycle, a large radial gap between SST flange and molybdenum appeared due to larger thermal expansion of the SST flange. This gap may have cause the non-uniform filling of the joint by the alloy.

Fig 2 When one of the sections was cut again (also by EDM) both flanges on one of the pieces (a 1/4 section of the whole) detached as shown

A possible solution that may reduce stresses caused by difference of thermal expansions could make use of an additional flexible part (in this case a cylinder) between molybdenum structure and SST flange. This thin-wall cylinder could be made out of stainless steel, CuNi, or copper and it should be properly designed to accommodate stressed created during the brazing. The joint between this flexible cylinder and molybdenum could be made with a groove that locks outside diameter of the cylinder as shown on figure 5a. This joint has to be properly designed to have adequate clearance when the parts at heated during the brazing. The design should also take into account thermally induced forces between the locking groove and the cylinder. The joint can be strengthened by locking not only outside diameter of the flexible cylinder, but also its inside diameter as shown on figure 5b. This, for example could be done for the flexible cylinder with large diameter.

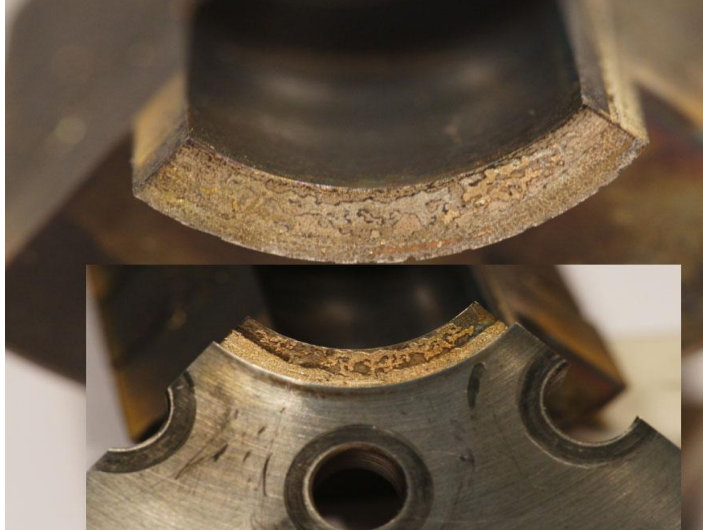
Fig 3 Highlight of joint failed in the right side of figure 2.

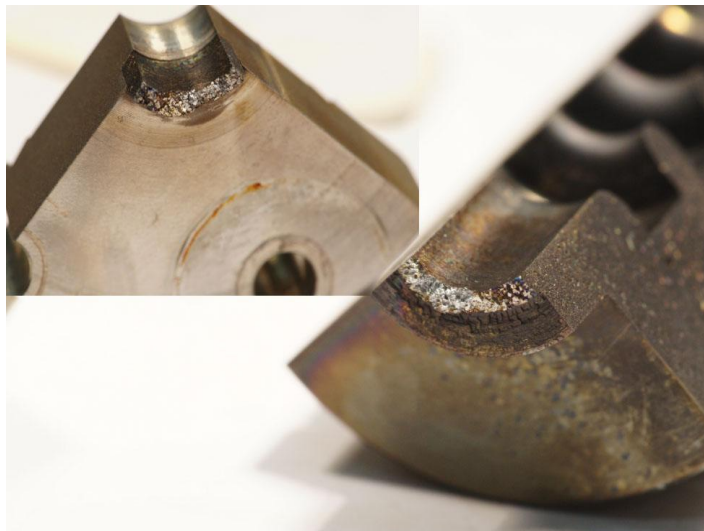
Fig 4 Highlight of molybdenum “extension tubes” failed adjacent to the SST flange in the left side of figure 2.

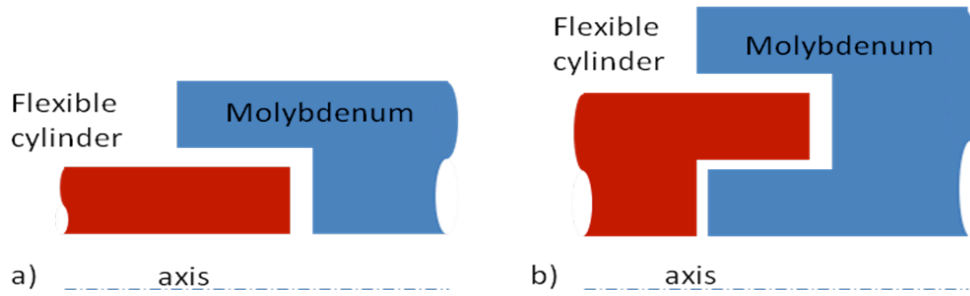
Fig 5 Possible joint designs between molybdenum and a flexible cylinder: a) locking outside diameter of the flexible cylinder; b) locking both inside and outside diameters of the flexible cylinder.

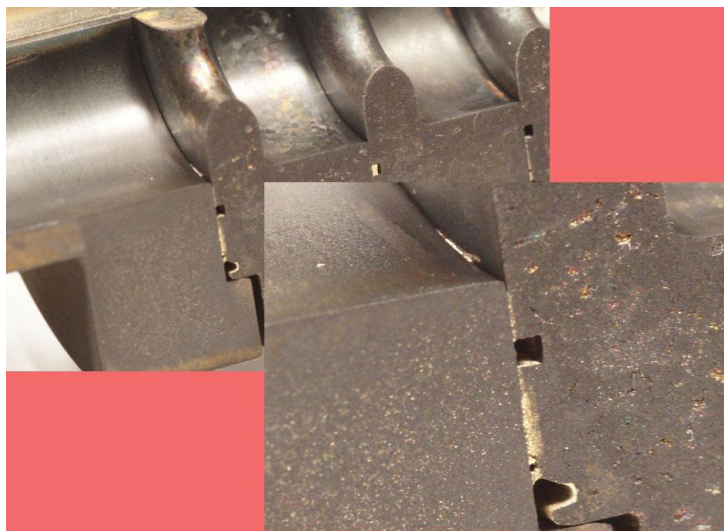
We think that the joins between structure cells could be improved by removing a void created by two contact surfaces on the iris side of the cell. This void is clearly visible on figure 6. The void could contribute to gas contamination and gas load during structure brazing and operation. For example, if inner contact surface has a vacuum leak and larger-diameter contact surface is vacuum tight, than this may adversely effect structure operation but would be hard to detect using conventional vacuum leak detection. By removing second-larger-diameter contacting surface we can improve contact between surfaces and avoid the uneven-alloy-filling of the joint seen on zoomed part of figure 6.

Fig.6 The image highlights a body/iris joint typical of moly structure.

We suggest a joint consisting of a single set of mating faces 1-3 mm wide between the body and iris. We may also use “nested” cells by creating a cylindrical step of ~1.5mm depth to lock the cells. The single mating surface will ensure contact at the cell-iris joint, would allow the cells to be made from much less material, and may significantly reduce the potential for contamination and virtual leaks. A multi-step braze sequence can be used to facilitate braze fillet control. In the noted design the first step would be a diffusion bond or an “alloy assisted” diffusion bond, if the body material and desired temperatures and pressures prevent direct bonding. Alloy assisted bonding uses temperature and pressure to create a bond between both sides of a filler (a thin “washer” in this case) and the base materials. If proper surface finishes, materials, temperatures, and pressures are used the resulting bond should be leak tight with a well “filled” joint. The joint can then be brazed traditionally with a lower temperature alloy to provide additional strength.

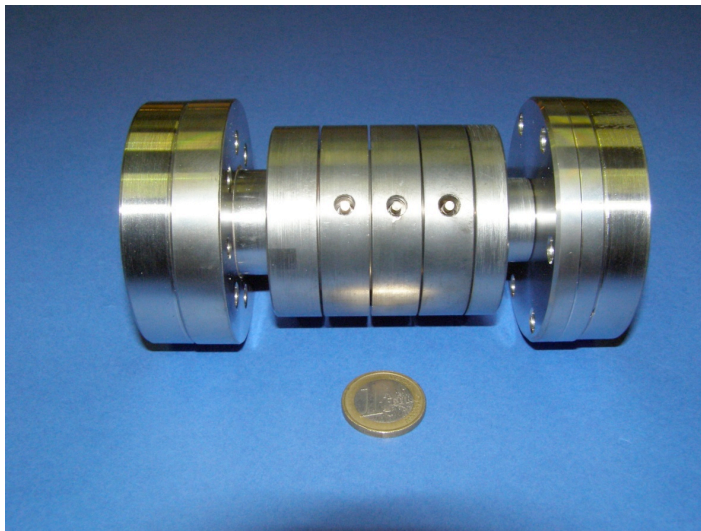
This time during high temperature brazing sequence several problems were occurred. The following procedure was applied for each connection made between the pieces: brazed joints were removed from the vacuum oven, checked for vacuum leaks, and only if vacuum test gave positive results, the brazing procedure carried on. Firstly, the external cells were brazed by using PalCusil 10 alloy (copper-based alloys are normally acceptable in the creation of relatively low resistance joints) with stainless steel flanges: the vacuum check gave positive results. After that the sequence continued with the brazing of the tuners; three cells, two tuners each one, two tuners each one, means a total of six tuners. The braze of these pieces was performed in two steps.

Step 2: Once done, the other three tuners were brazed with Palcusil 5 in order to avoid problems with the previous joint done. After that the entire structure was assembled and the final braze was attempted. To avoid problems related to previous brazed parts, Cusil was adopted because the brazing temperature is less than Palcusil. Cusil was used to achieve the final structure, putting a thin layer of electrolytic copper placed at the joining surfaces. After that, during vacuum check, a leak in the part of conjunction between the molybdenum and stainless steel was found. We tried to redo the braze to see if leak disappeared but without results. We tried to redo the brazing procedure alternating Cusil with Palcusil alloy but no improvements took place. We also tried to make a new geometry of the joints surface to facilitate the brazing process, but again without results. In the figure 8 the assembled molybdenum structure is shown. Unfortunately the vacuum leak between the molybdenum and stainless steel right flange is again present. The thermal treatments on the structure changed significantly the dimensions, especially in the conjunction area between molybdenum and stainless steel; in order to keep the initial dimensions the structure has been machined again and a new brazing process was attempted in order to close the vacuum leak at stainless steel flanges, but again without results.

Fig. 8 The assembled molybdenum structure.
