## 2011 ACTIVITY REPORT OF THE HCP\_AF GROUP

### 1. Aim of the experiment

### 3. Brazed section internal inspection

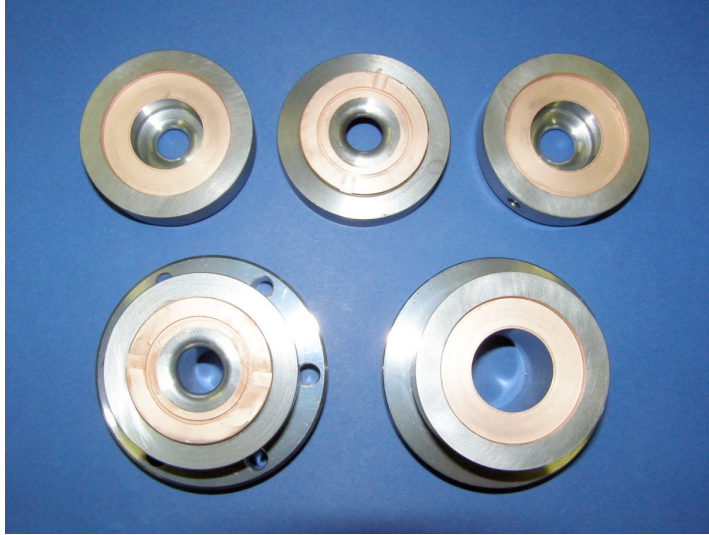
We think that the joins between structure cells could be improved by removing a void created by two contact surfaces on the iris side of the cell. This void is clearly visible on figure 6. The void could contribute to gas contamination and gas load during structure brazing and operation. For example, if inner contact surface has a vacuum leak and larger-diameter contact surface is vacuum tight, than this may adversely effect structure operation but would be hard to detect using conventional vacuum leak detection. By removing second-larger-diameter contacting surface we can improve contact between surfaces and avoid the uneven-alloy-filling of the joint seen on zoomed part of figure 6.

Fig.6 The image highlights a body/iris joint typical of moly structure.
